Power Quotient International Co., Ltd.

PQI iConnect Plus not recognized by PQI iConnect APP issue

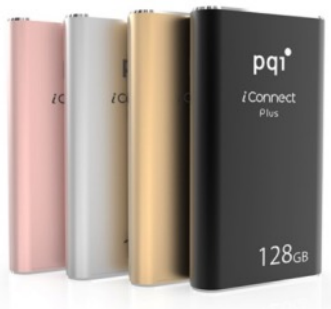
Recently, PQI iConnect Plus have not been able to be recognized by PQI iConnect APP. The cause of this is due to a compatibility issue when upgraded to Apple iOS 11.2.

1. Please confirm that you have installed the latest iOS update.
2. Please also confirm that iConnect Plus is not recognized by PQI iConnect APP.
3. Please click on the following to download update software: iConnect Plus_FW UpdateTool (this must be performed in a Windows environment).
4. Plug iConnect Plus into the USB port of the Windows PC/ laptop.
5. Double click on "iConnect Plus_FW UpdateTool".
6. Click on "Update".
7. When completed, "Update successful" will appear and click on "OK" to complete the update process.
